Production Engineering Measures Program
Manufacturing Methods and Technology

FORGE-DIFFUSION BOND TITANIUM ROTOR HUB EVALUATION

MARON J. BONASSAR and JOHN J. LUCAS

SIKORSKY AIRCRAFT

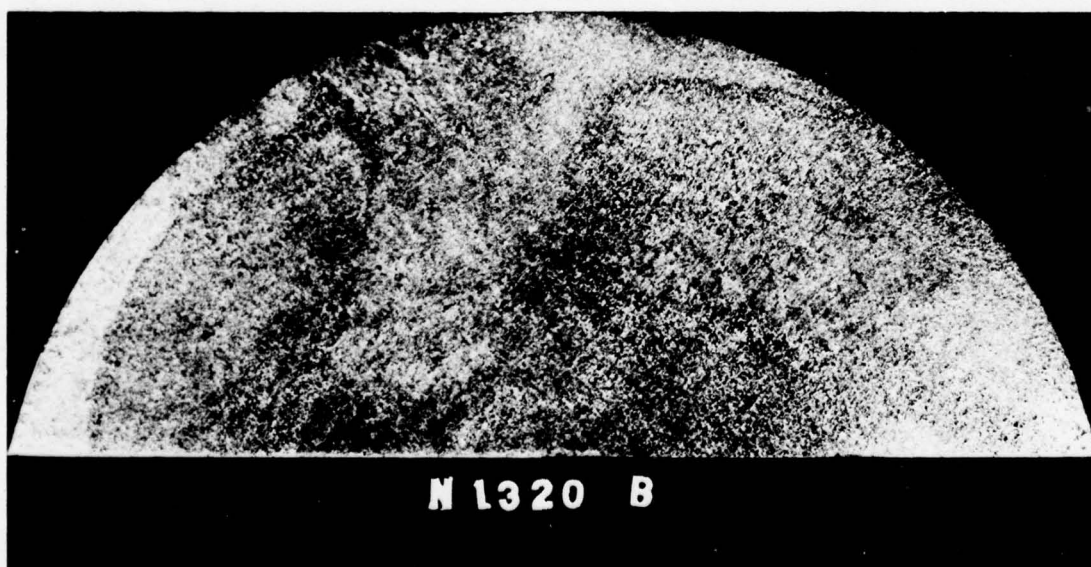
TOP SIDE

BOTTOM SIDE

FIGURE 5. MACROSTRUCTURE OF Ti-6Al-4V FORGING STOCK MATERIAL,
FORGE-DIFFUSION BOND OF SIMPLE PANCAKE FORGINGS. .75X

Nine-inch round Ti-6Al-4V alloy forging stock material conforming to the requirements of Sikorsky Standard 8445 Reference (4) was procured from Titanium Metals Corporation of America (TMCA). Chemical analysis of the material is provided in Table II and indicates its acceptability. Metallographic examination of the top and bottom of the forging stock material indicated a material of good quality. The macrostructure was uniform with recrystallized fine beta grains, as shown in Figure 5. The microstructure exhibited a very acceptable alpha particle size for forging stock material, as shown in Figure 6.

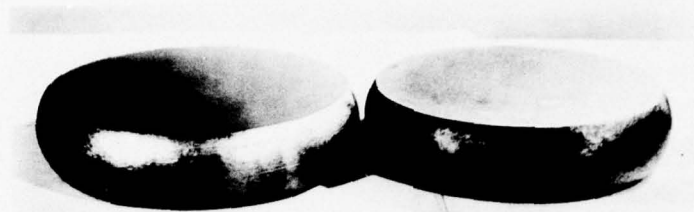
FIGURE 7. TWO TYPICAL MACHINED AND
CHEMICALLY CLEANED PANCAKES.

The pancakes were sandblasted and one forged surface from each pancake was machined to a final thickness of 3.5-inches. The machined pancakes were chemically milled (chem-milled) in a standard hydrofluoric-nitric acid aqueous solution (3% HF, 30% HNO₃) for removal of surface contaminants. Figure 7 depicts two typical machined and chem-milled pancakes. The chem-milled surfaces of two pancake segments were mated and the assembly was placed on a stainless steel plate, Figure 8. A prefabricated expendable stainless steel cover with an air evacuation tube was positioned over the pancake assembly, Figure 9, and the steel container (retort) was sealed by a Tungsten Inert Gas (TIG) weld. This procedure was followed for all five of the assemblies to be bonded.

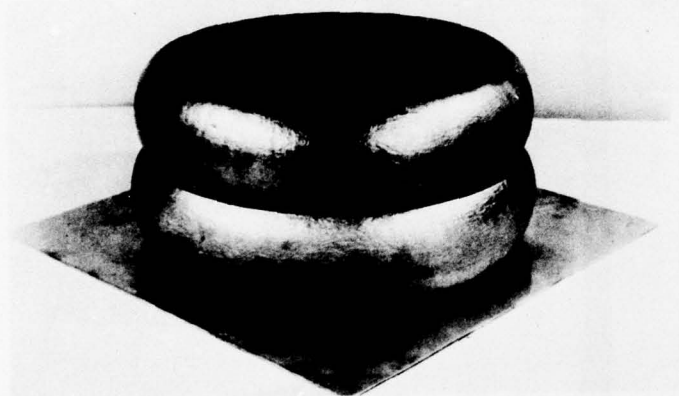
FIGURE 8. PANCAKE ASSEMBLY POSITIONED
ON STAINLESS STEEL PLATE.

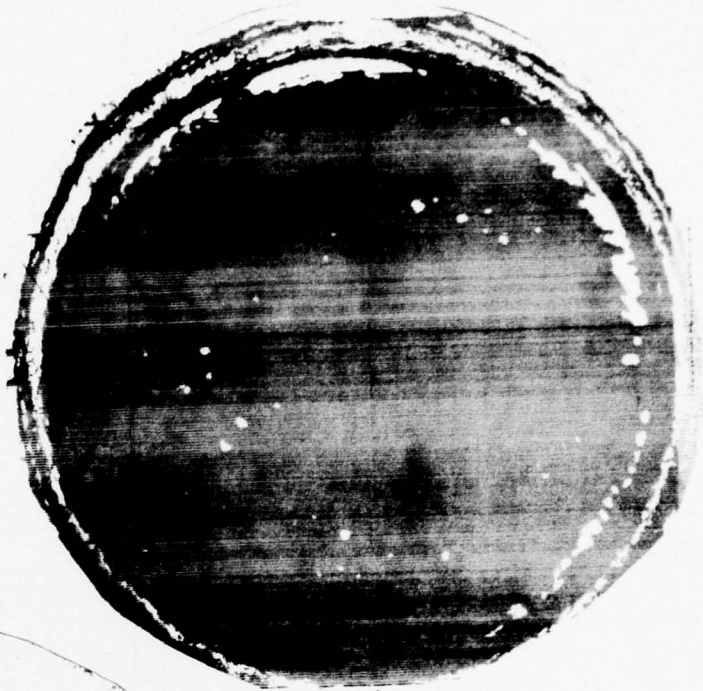
FIGURE 17. C-SCAN RECORDINGS OF FIVE PANCAKE ASSEMBLIES,
ALARM LEVEL 100% OF #3 fbh IN REFERENCE BLOCK.

indications of nonbonded areas were significantly decreased. The indication of nonbonded areas were less than 1% for assemblies Condition 1, and less than 5 to 15% for assemblies Conditions 2, 3, and 4. The most severe condition was Condition 5, the low temperature bonded assembly which exhibited 89% nonbonded area. C-scan recordings of each of the five pancake assemblies at this sensitivity level are provided in Figure 17.

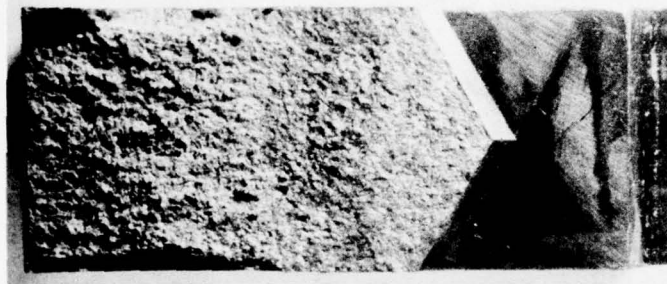
FIGURE 30. FRACTURE TOUGHNESS INTERFACE,
TYPICAL FRACTURE INTERFACE
TRIAL PANCAKE ASSEMBLIES. 1.5X

Fracture Toughness - Fracture toughness results are presented in Table V. Review of the test data discloses valid and nonvalid values, as defined by the requirements in ASTM-E399-72, Reference (7). K_{IC} values which do not meet the requirements of Reference (7) cannot be reported as valid K_{IC} values and are reported as K_Q values. Condition 1 exhibits slightly higher fracture toughness characteristics than Condition 2 and 20% higher than Condition 3. All of the Condition 4 results are invalid. The fracture toughness specimens displayed fracture surfaces with normal flat brittle fatigue precracking followed by overload plane strain cracking. Crack propagation was transgranular in nature exhibiting a fine grain fracture interface for both the precrack and plane strain cracking regions as shown in Figure 30. The only variation was Condition #4 which manifested a relative coarser static fracture surface, as shown in Figure 31. No evidence of voids or contamination was observed on these fracture interfaces that could have generated the different fracture surface texture.

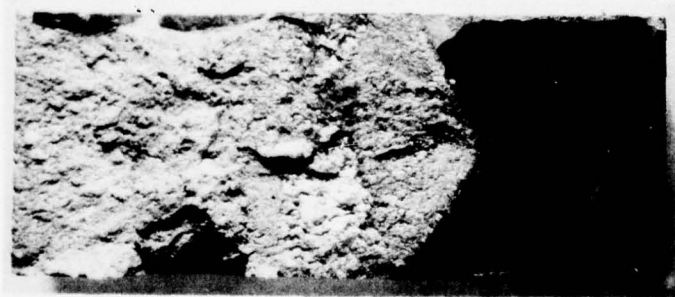
FIGURE 31. FRACTURE TOUGHNESS INTERFACE
CONDITION 4, NOTE COARSER
STATIC FRACTURE SURFACE. 1.5X

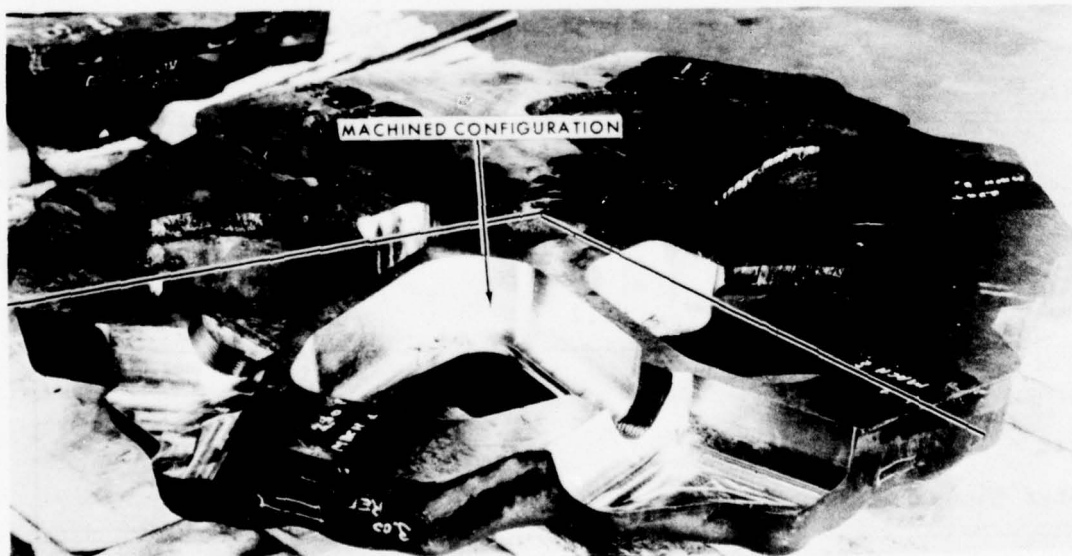
FIGURE 40. HALF-FORGING SHOWING PARTIALLY MACHINED CONFIGURATION.

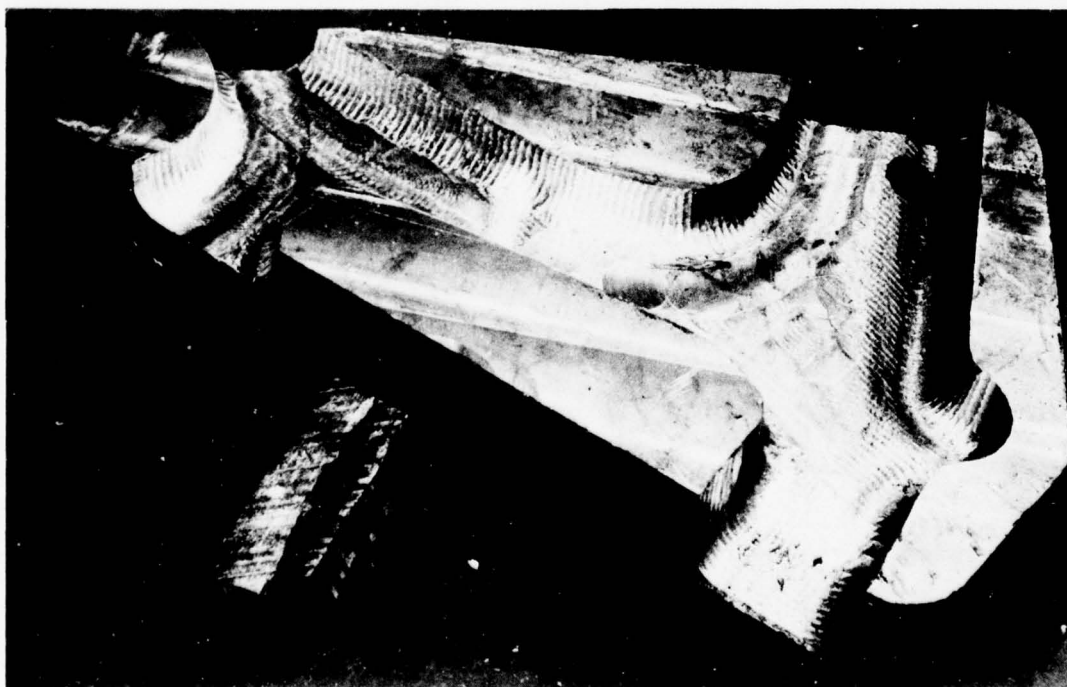
FIGURE 42. TOP AND BOTTOM BONDING DIES, ROUGH MACHINED.

The bonding deformation stroke was to be the same 10% as established in Phase I. The hub forging thickness varies from 13-inches at the center to 9.4-inches at the periphery. An average thickness of the arm segment appeared to be approximately 10-inches. A 10% reduction would require a 1-inch bonding press stroke. Because of the size and shape of the upper and lower arm segments, it was necessary to fabricate forge bonding dies to transmit pressure uniformly, maintain alignment and to utilize a container or retort of a relatively simple geometry. This would increase the reliability of obtaining an adequate vacuum. Bonding dies were machined from forge flattened billets of type 304 stainless steel. The dies were designed with sufficient impression depth to assure the upper and lower arm segments would be held securely during the bond stroke. Adequate clearance was provided in the impression to allow for variation in thermal expansion of stainless steel and titanium. Two 2-inch diameter type 304 stainless steel leader pins were installed vertically between the top and bottom bonding dies to minimize shifting of the dies during the bond stroke. Figure 41 illustrates the general arrangements of the arm segments in bonding die. Figure 42 shows the top and bottom bonding dies with the machined impression before grinding and leader pin installation.

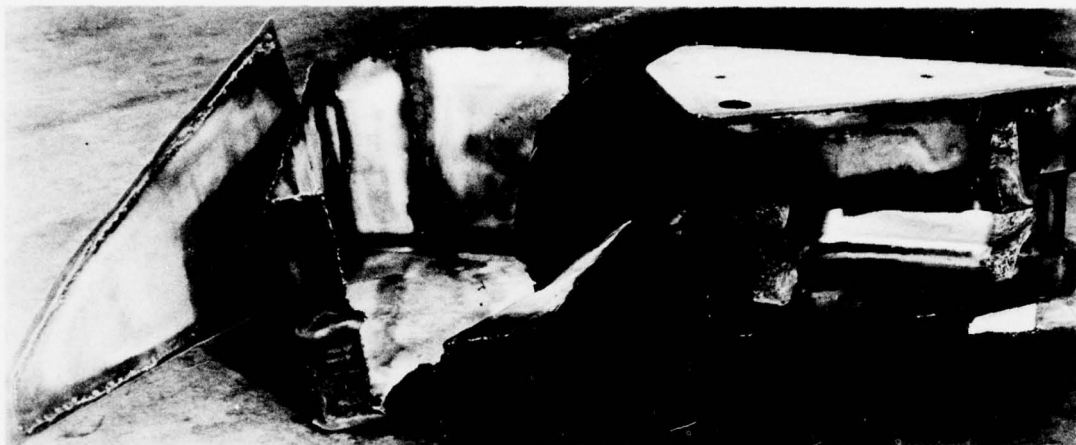
FIGURE 50. RETORT, DIE, AND ARM SEGMENT AFTER THE FORGE-BOND AND POST BOND ANNEAL, THIRD ARM SEGMENT.

The retort was opened for an early evaluation of the arm segment as shown in Figure 50. Details relating to the investigation of the preliminary sonic indication are presented in Section 5.4.2 on Hub Arm Inspection. The arm segment was then thermally treated at 1900°F for one-hour at temperature, water-quenched, annealed at 1300°F for two-hours and air cooled. These operations completed fabrication of the single hub arm risk reduction segment. Inspection and destructive testing were the next major efforts as discussed in Sections 5.4.3 and 5.5.

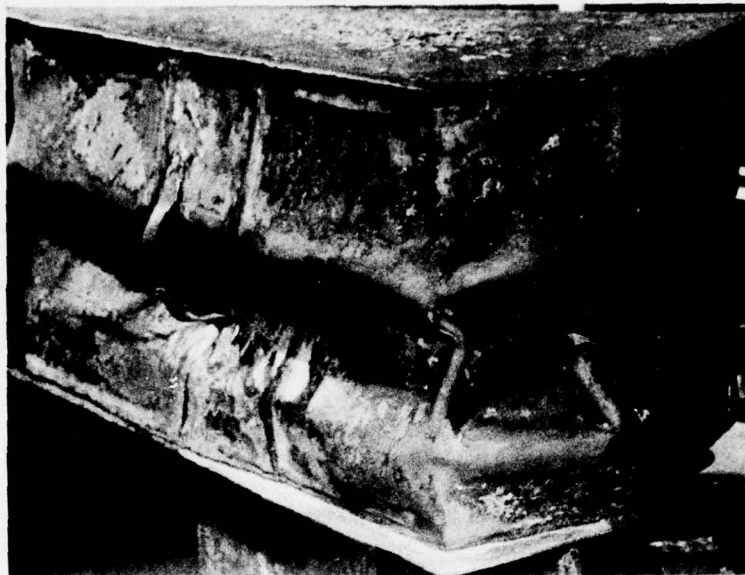
FIGURE 56. RETORT UNIT AFTER FORGE-BOND AND THERMAL TREATMENT, FIRST HUB ARM SEGMENT.

Upon completion of the forge-bond operation the retort unit was reloaded into the furnace and the temperature was raised from 1750°F to 1900°F. It is estimated that the temperature of the arm segment was in the vicinity of 1650°F. After two hours, the retort unit was water quenched. Figure 56 shows the deformed retort unit after the forge-bond and water quench operation. The first arm segment was removed from the container and annealed at 1300°F for two hours at temperature. Figure 57 shows the first forge-bond arm segment after bonding. Figure 58 illustrates how the deformation occurs in a section through a typical arm segment.

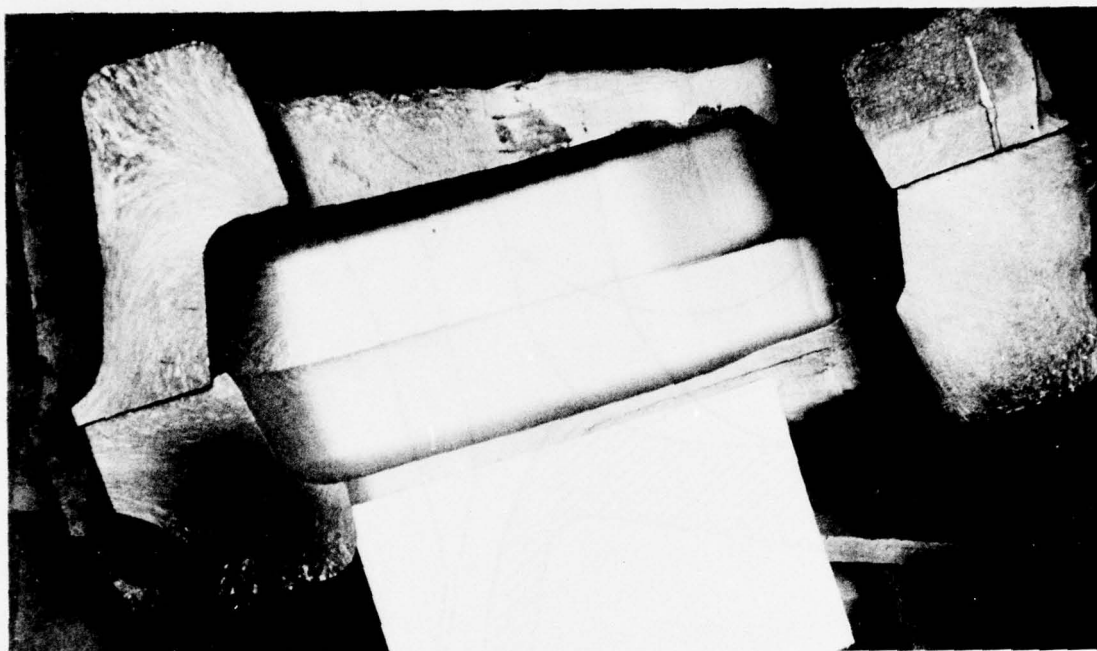
FIGURE 67. THIRD HUB ARM SEGMENT AS REMOVED FROM RETORT.

3rd Hub Arm - After the forge-bond and post-bond thermal treatment at 1750°F, the retort was opened by cutting and the third arm segment was removed from the bonding dies. Generally, the arm segment was bright, manifesting a noncontaminated surface. Only one area on the arm segment disclosed a minute area of possible contamination. Figure 67 shows the arm segment as it was removed from the retort.

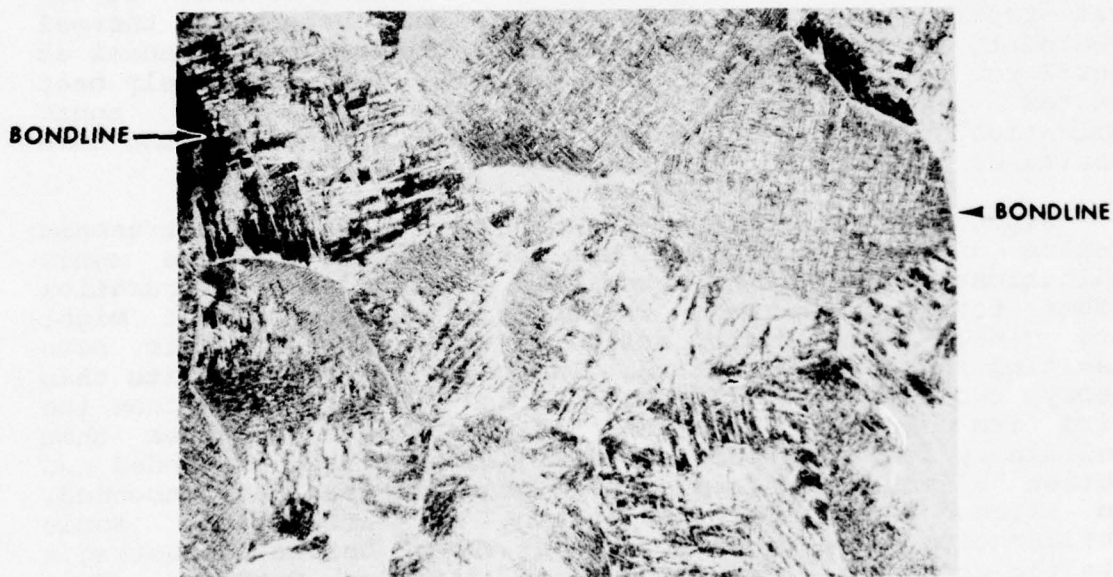
FIGURE 70. MICROSTRUCTURE ACROSS BONDLINE OF THIRD HUB ARM SEGMENT, AFTER FINAL BETA HEAT TREAT AGAIN DISCLOSED NO GROSS LACK OF BOND. 50X

Transverse slices were cut from an area exhibiting some indications of nonbonding. Contrary to the ultrasonic indications, macrostructure examination disclosed an apparent good diffusion bond. The forging flow lines were evident in the alpha-beta macrostructure and tended to bring out the bondline location. Figure 69 depicts the macrostructure across the bondline. Micro-examination of the same area revealed no evidence of cracking, lack of bond, contamination or other discontinuities at the joint interface. In order to examine the bondline in more detail, a segment of the macrospecimen was processed in accordance with the final beta heat treatment. The heat treatment consisted of 1900°F for one-hour, water-quench, anneal at 1300°F for two hours and air cool. Metallurgical examination again disclosed no gross lack of bond in the beta structure which appeared to be homogeneous as shown in Figure 70 with no indication of the bondline location.

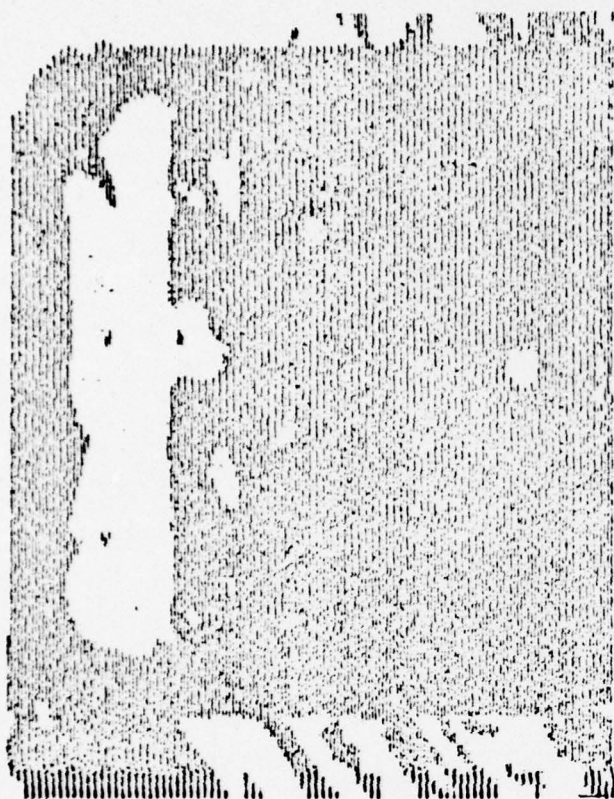
SIKORSKY BLOCK
 #3 HOLE $-3\frac{3}{8}$ " M.T.
 CRYSTAL #LH6635-5MHZ $\frac{3}{4}$ " FLAT
 GAIN=3.6 AT $\times 1$ 2" AMP
 ALARM LEVEL =25% BR=1

W-G STD
 #3 $2\frac{1}{4}$ 3" MT
 CRYSTAL #LH 6635-5MHZ $\frac{3}{4}$ " FLAT
 GAIN=0.4 AT $\times 1$ 2" AMP
 ALARM LEVEL =25% BR=4+

FIGURE 74. C-SCAN RECORDINGS OF MACHINED TEST BLOCK "B"
 FROM THIRD HUB ARM SEGMENT WITH PRELIMINARY
 SONIC INDICATION.

a sonic response denoting a bonded joint. Figures 73 and 74 are copies of the sonic C-scan recordings of the two machined test blocks to two inspection standards. Test block dimensions are also illustrated in these figures. These results indicate an adequately bonded arm and substantially confirm that the sonic indications initially observed in the full size arm segment are associated with the arm configuration.

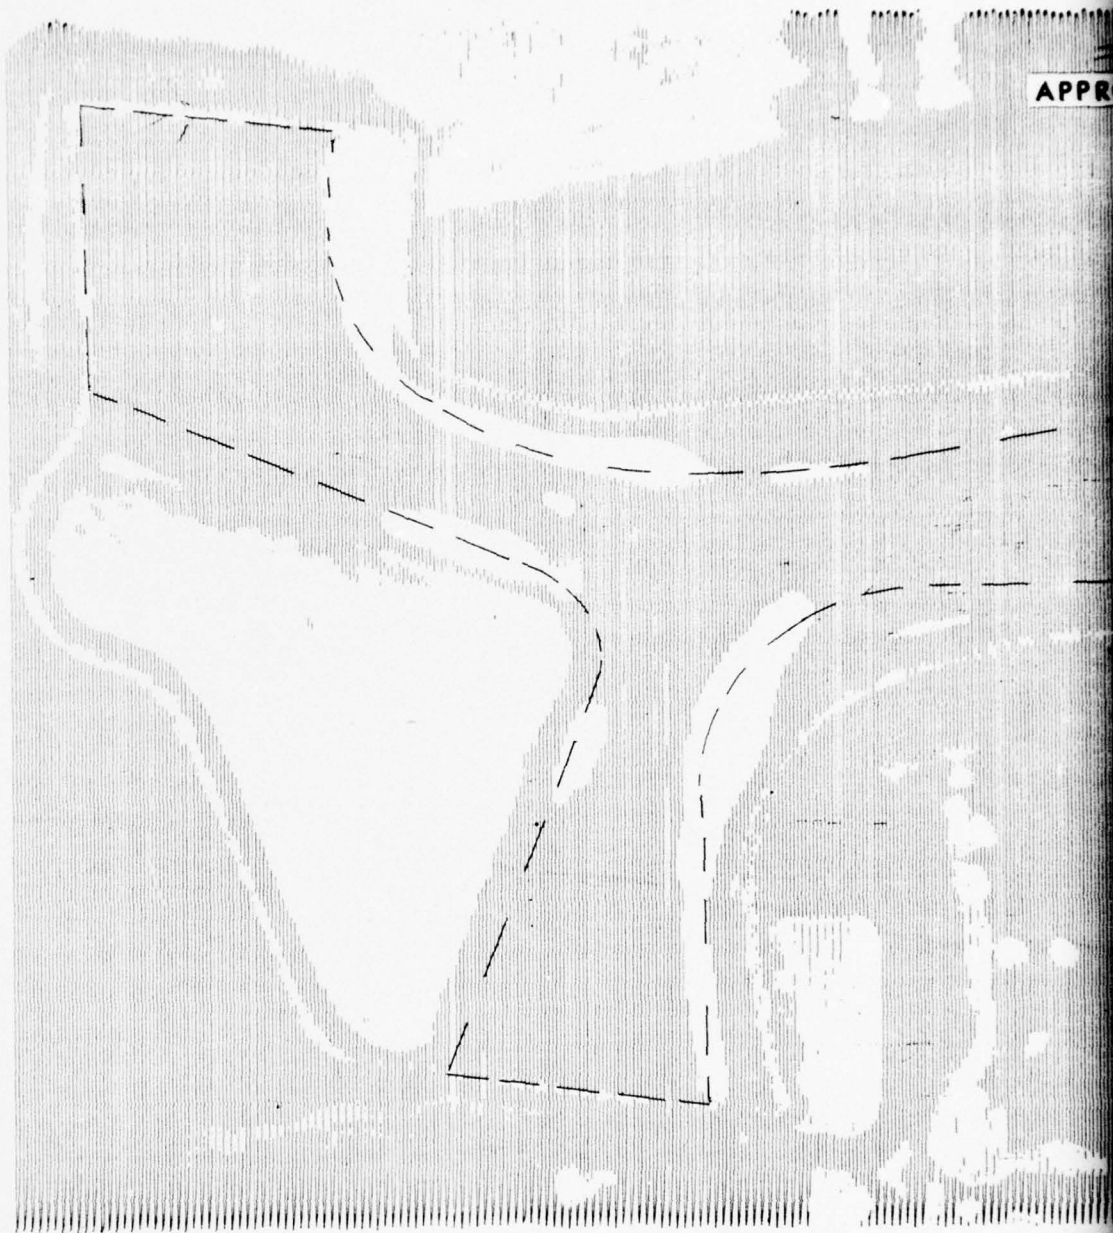
FIGURE 76. C-SCAN RECORDING OF FOURTH HUB ARM SEGMENT,
80% OF #4 fbh IN REFERENCE BLOCK.

4th Hub Arm - Following completion of the fabrication process, the fourth arm segment was machined top and bottom surfaces to an ultrasonic inspection configuration. The technique used in inspection of the fourth arm was the same as employed for the third arm. Results of this inspection disclosed a satisfactory joint with no evidence of gross lack of bond. C-scan recordings portrayed a similar read-out, as obtained previously from the third arm. Figure 76 is a copy of a C-scan recording of the fourth arm segment depicting the familiar anomalies along the periphery.

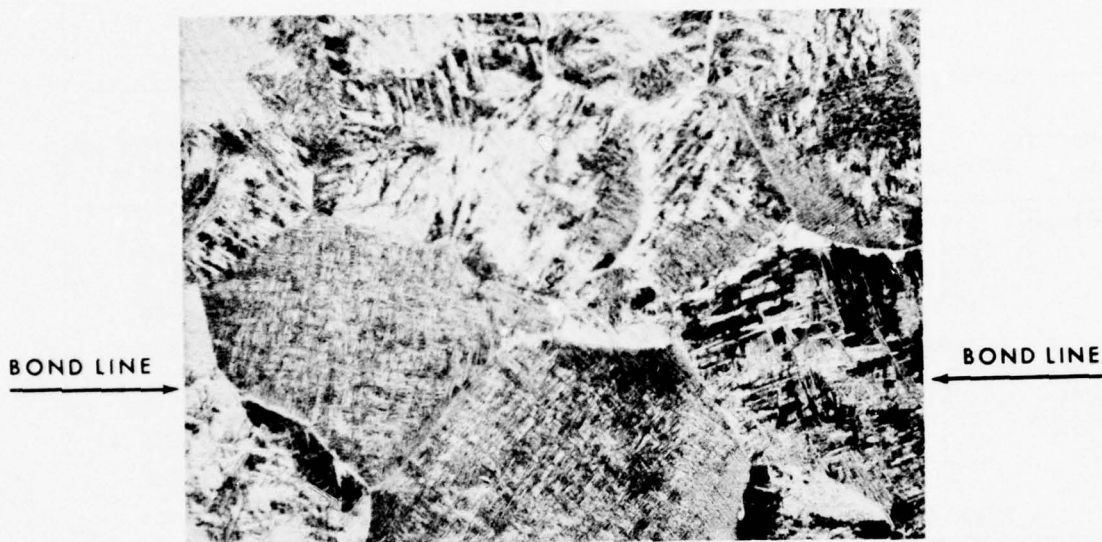
FIGURE 86. TYPICAL CROSS SECTION OF BONDLINE, NO EVIDENCE OF ANY ANOMALIES, BOND JOINT IS NOT DISTINGUISHABLE FROM PARENT MATERIAL. 50X

General - Analysis of the mechanical properties of the parent material and the forge-bond joint revealed no significant differences. The results indicated a high quality diffusion bonded joint had been obtained. A summary of the test results is provided in Figure 85. Visual evaluation of the tested specimens, parent material and bondline revealed that all the specimens failed in the test region and are considered valid tests. The bondline specimens separated within the test section as designed. Fracture examination of the tensile, fracture toughness, in-line shear, and fatigue initiation specimens for the parent material and bondline specimens revealed the mode and mechanism of failure to be typical as related to the particular type of tests conducted. No evidence of any abnormalities were detected on the fracture surface of the bondline specimens that could have caused or contributed to premature failures. Microstructure examination of cross sectional areas of bondline specimens revealed no evidence of failure initiation due to an anomaly at the bondline. No significant differences were observed between the parent material and bondline specimens. Metallographic examination of cross sectional segments of bondline specimens and macroslices disclosed no evidence of voids, contamination, or lack of bond. In most instances, metallographic examination could not distinguish the bond joint from the parent material, as illustrated in Figure 86.

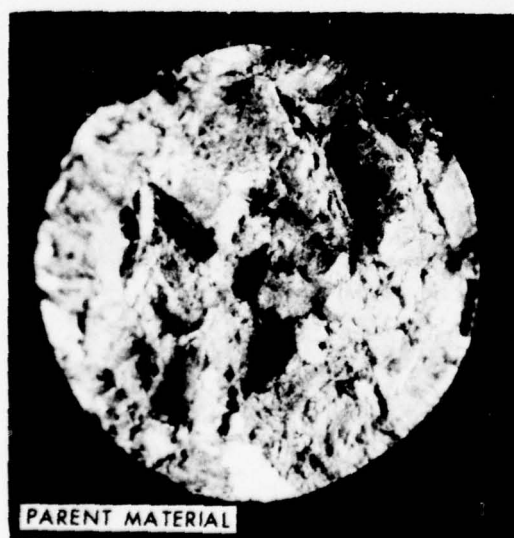
FIGURE 87. TENSILE FRACTURE, TYPICAL DUCTILE BREAK, HUB ARM SEGMENT. 10X

Tensile - Comparison of the tensile test data, Table XIV showed that the tensile values were generally the same for both parent material and bondline specimens. Both the parent material and bondline failed tensile specimens exhibited typical ductile breaks with cup-cone interfaces as shown in Figure 87. No evidence of bondline separation was observed. No significant differences were observed between the parent material and bondline fracture interfaces.

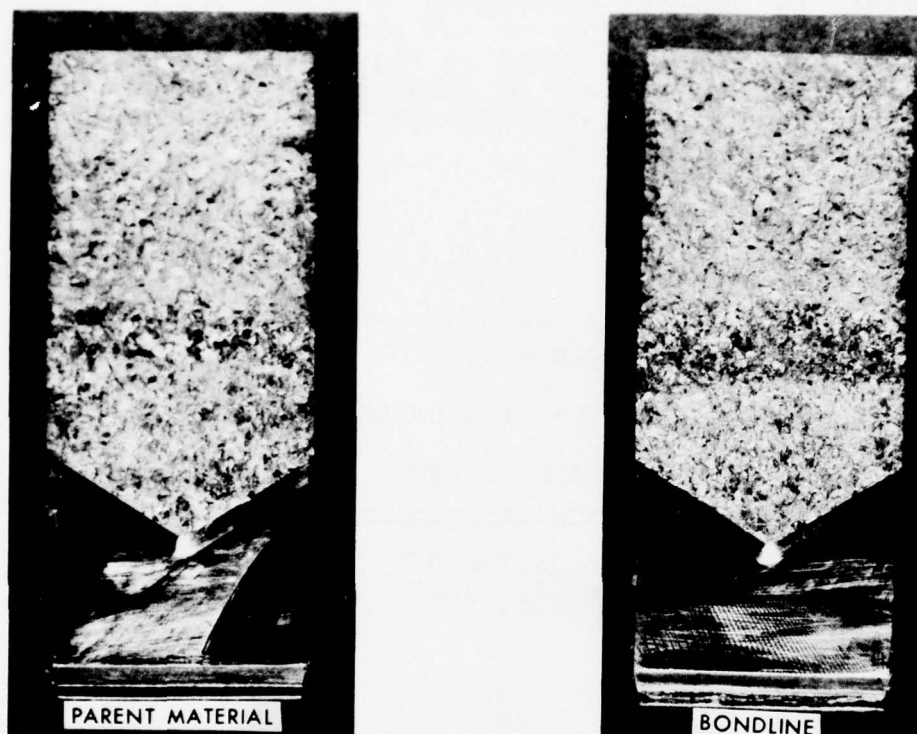
FIGURE 88. FRACTURE TOUGHNESS TYPICAL FRACTURE INTERFACE, HUB ARM SEGMENT. 1.5X

Fracture Toughness - Fracture toughness results are presented in Table XV. Review of the data disclosed no significant differences and all the test values are valid, meeting all criteria for determination of valid K_{IC} measurements described in ASTM-E399-72 (Reference (7)). The specimens displayed fracture surfaces with normal flat brittle fatigue precracking followed by overload, plane strain cracking for both the parent material and bondline specimens. Crack propagation was transgranular in nature exhibiting a fine grain fracture interface for both the precrack and plane strain crack region of both type specimens as shown in Figure 88. No evidence of voids, contamination, or lack of bond was observed on the fracture interface of the bondline specimens that could have generated a premature failure.

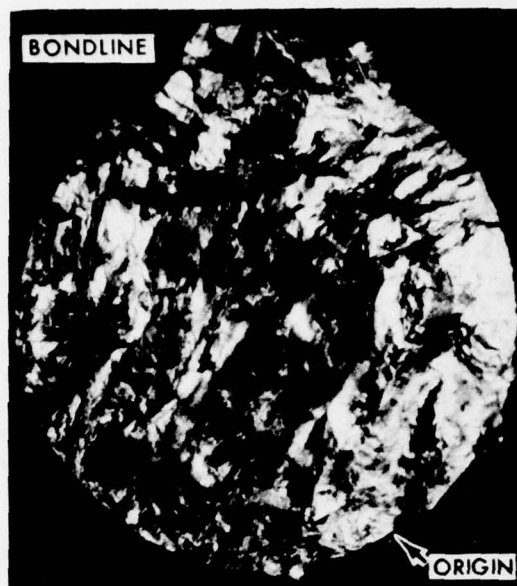
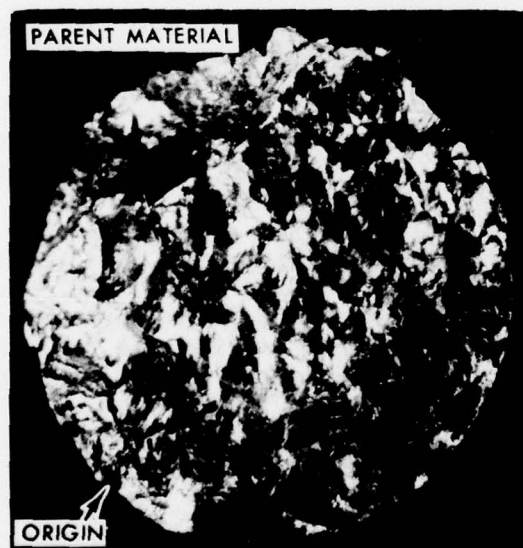
FIGURE 91. FATIGUE FRACTURE, TYPICAL FRACTURE SURFACE WITH ORIGIN ON O.D., HUB ARM SEGMENT. 11X
